Inspection Report

ClearVUE Home Inspection
704.778.1965

October 8, 2019

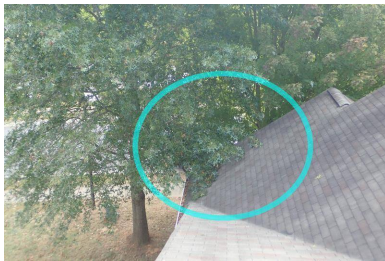
1. Trees are touching or overhanging the roof on the home at the Front of the home; continual maintenance is needed to prevent damage.

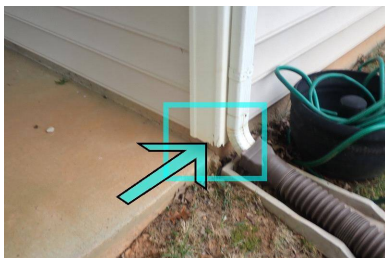
2. There is damage to the trim noted at the bottom (typical to weed eater damage) that needs repair and/or replacement to prevent water penetration in areas around the home.

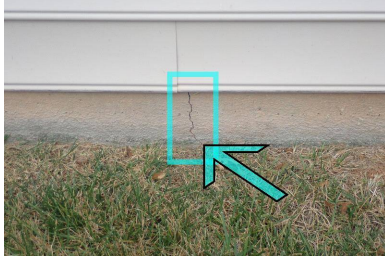
3. There is a crack noted at the visible portion(s) of the homes concrete slab/foundation along the following locations. Unable to determine if the crack continues into and/or throughout the interior slab of the home due to floor coverings blocking and/or obstructing viewing of the slab. The cracks on the exterior of the home that could be viewed need to be properly sealed to prevent water penetration and/or continual cracking. It is recommended at a minimum to continue to monitor. To determine the full extent of the cracking, a qualified contractor is

needed to further evaluate the extent of the damage and make any additional recommendations as to additional repairs as needed or deemed necessary.

- Right side of the home.

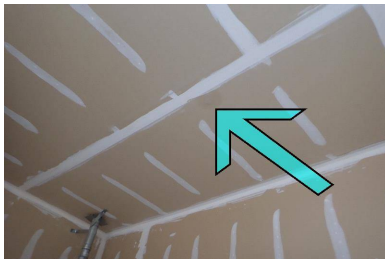
4. Stains noted on the ceiling in the garage. Unable to determine if an active leak exists at the time of inspection. Ask the seller the history of the stains and if repairs have been made to correct any leaks that may have caused the stain. If the sellers aren't aware of the stain or the home is vacant, then the stain should be treated as active. Water penetration into the ceiling can lead to problems if left unattended.

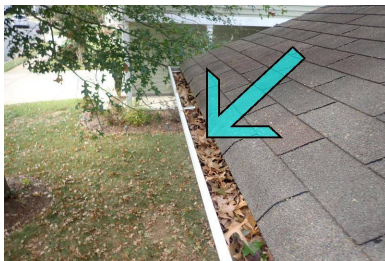
5. The gutters and/or gutter guards are full of debris and need to be cleaned out to allow for proper drainage. Proper corrections are needed to efficiently direct water away from the foundation of the home.

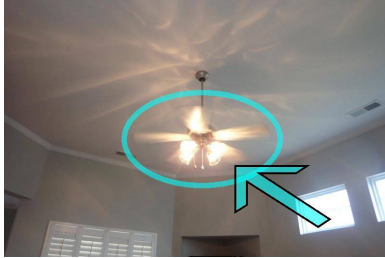
6. There is one or more ceiling fan(s) that is not balanced and/or moving during normal operation within the home and needs to be properly balanced, adjusted, repair, and/or replaced to prevent possible/further damage.

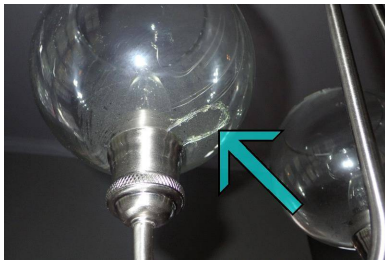
7. The glass portion of the light fixture located in the following areas was noted to be cracked/broken at the time of the inspection. Replacement is advised to insure safety and proper operation of the fixture.

- Dining/Breakfast area.

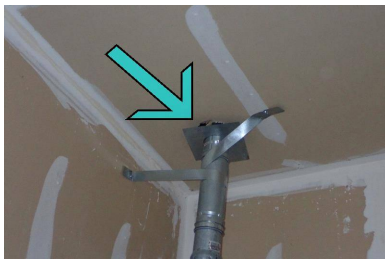
9. The vent collar is loose or missing where the water heater flue enters the ceiling/wall of the garage and needs to be installed properly to serve the purpose in which the collar was intended (maintaining fireproof barrier).

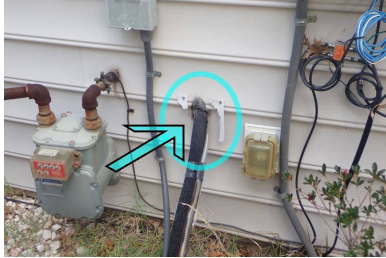
10. The exterior weather guard was noted to be damaged at the siding along the home where the freon lines enter the wall. It is recommended the rain guard be repaired/replaced to provide an extra protection against moisture intrusion along this area.

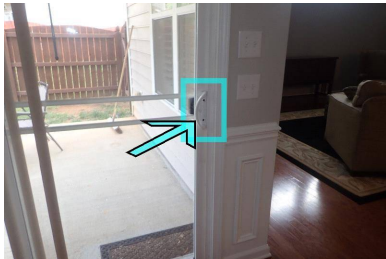
11. The door lock(s)/dead bolts were noted to be loose/damaged to the point in which the lock is not engaging consistently located at the following areas of the home at the time of the inspection. Proper corrections and/or repairs are needed in order for the lock to properly engage.

- Rear entry sliding glass doors.

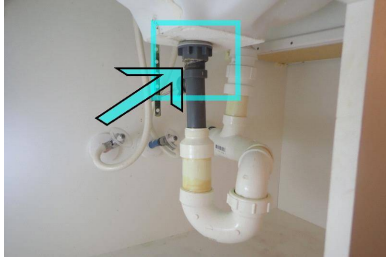
13. Due to the follow but not limited to the listed items below. Repairs and/or corrections are needed within the **Entry level hallway bathroom**. A qualified licensed contractor should be consulted to further evaluate the bathroom and determine the full extent of the damage and/or if additional repairs are required or deemed necessary, as there may be additional defects that were concealed and/or otherwise unseen at the time of the original inspection.

- There is an active leak at the drain connections under the sink. Proper corrections and/or repairs are needed in order to prevent possible/further damage from moisture intrusion.

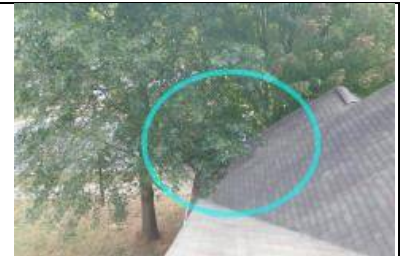
Trees are touching or overhanging the roof on the home at the Front of the home; continual maintenance is needed to prevent damage.

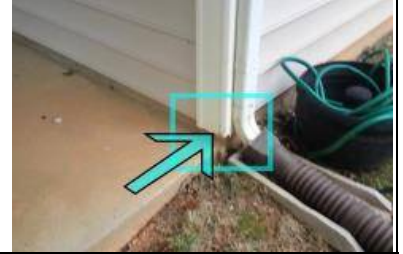
There is damage to the trim noted at the bottom (typical to weed eater damage) that needs repair and/or replacement to prevent water penetration in areas around the home.

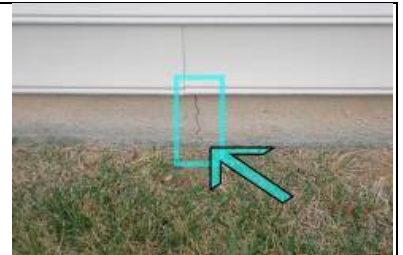
There is a crack noted at the visible portion(s) of the homes concrete slab/foundation along the following locations. Unable to determine if the crack continues into and/or throughout the interior slab of the home due to floor coverings blocking and/or obstructing viewing of the slab. The cracks on the exterior of the home that could be viewed need to be properly sealed to prevent water penetration and/or continual cracking. It is recommended at a minimum to continue to monitor. To determine the full extent of the cracking, a qualified contractor is needed to further evaluate the extent of the damage and make any additional recommendations as to additional repairs as needed or deemed necessary.

- Right side of the home.

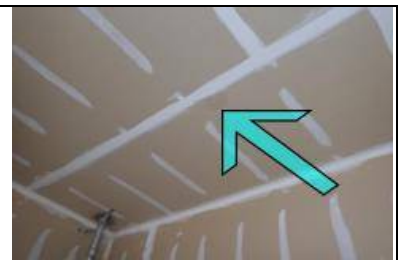
Stains noted on the ceiling in the garage. Unable to determine if an active leak exists at the time of inspection. Ask the seller the history of the stains and if repairs have been made to correct any leaks that may have caused the stain. If the sellers aren't aware of the stain or the home is vacant, then the stain should be treated as active. Water penetration into the ceiling can lead to problems if left unattended.

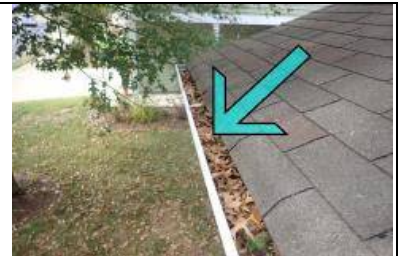
The gutters and/or gutter guards are full of debris and need to be cleaned out to allow for proper drainage. Proper corrections are needed to efficiently direct water away from the foundation of the home.

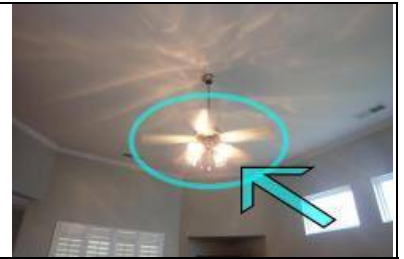
There is one or more ceiling fan(s) that is not balanced and/or moving during normal operation within the home and needs to be properly balanced, adjusted, repair, and/or replaced to prevent possible/further damage.

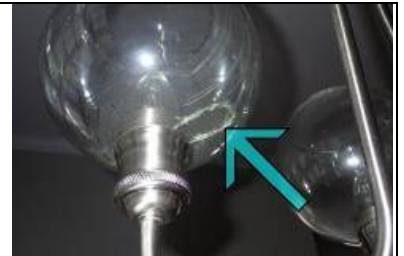
The glass portion of the light fixture located in the following areas was noted to be cracked/broken at the time of the inspection. Replacement is advised to insure safety and proper operation of the fixture.

- Dining/Breakfast area.

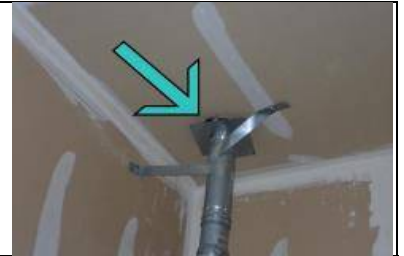
The vent collar is loose or missing where the water heater flue enters the ceiling/wall of the garage and needs to be installed properly to serve the purpose in which the collar was intended (maintaining fireproof barrier).

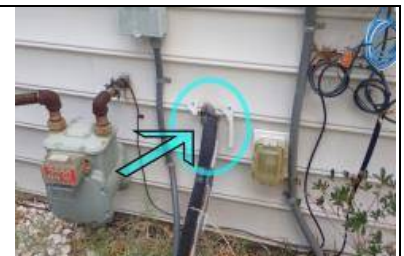
The exterior weather guard was noted to be damaged at the siding along the home where the freon lines enter the wall. It is recommended the rain guard be repaired/replaced to provide an extra protection against moisture intrusion along this area.

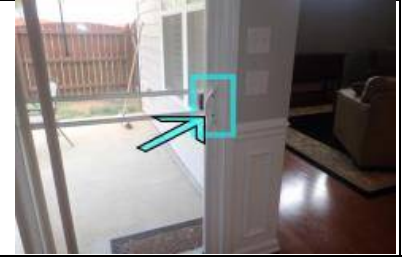
The door lock(s)/dead bolts were noted to be loose/damaged to the point in which the lock is not engaging consistently located at the following areas of the home at the time of the inspection. Proper corrections and/or repairs are needed in order for the lock to properly engage.

- Rear entry sliding glass doors.

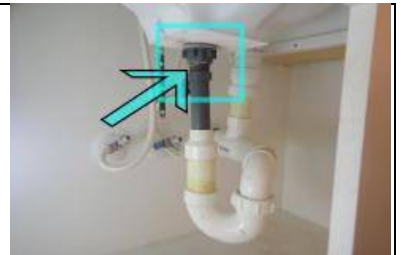
Due to the follow but not limited to the listed items below. Repairs and/or corrections are needed within the **Entry level hallway bathroom**. A qualified licensed contractor should be consulted to further evaluate the bathroom and determine the full extent of the damage and/or if additional repairs are required or deemed necessary, as there may be additional defects that were concealed and/or otherwise unseen at the time of the original inspection.

- There is an active leak at the drain connections under the sink. Proper corrections and/or repairs are needed in order to prevent possible/further damage from moisture intrusion.
